GENEVA STATION LEVEL CROSSING COLLISION BOARD OF INQUIRY REPORT			
OPERATOR		PASSENGER RAIL AGENCY OF SOUTH AFRICA (PRASA)	
PERMIT NUMBER		ASP 0002 NTS	
INVESTIGATION SUBJECT		INVESTIGATION REPORT INTO THE LEVEL CROSSING COLLISION OF 04 JANUARY 2018 CLOSE TO GENEVA STATION INVOLVING A MAIN LINE PASSENGER SERVICES (TRAIN NUMBER 37012) AND A ARTICULATED TRUCK (REGISTRATION JCW 868 NW).	
DATE OF OCCURRENCE		04 JANUARY 2018	
REFERENCE NUMBER		RSR/20180104/002	
BOARD OF INQUIRY MEMBERS			
CHAIRPERSON	MR PHATUDI MAPONYA	MAPONYA INCORPORATED	
ELECTRICAL EXPERT	DR WILLEM SPRONG	GIBB	
ROLLING STOCK EXPERT	MR GIVEN MABASO	MJT CONSULTING	
HUMAN FACTORS EXPERT	MR MOSES SHABA	RAILWAY SAFETY REGULATOR

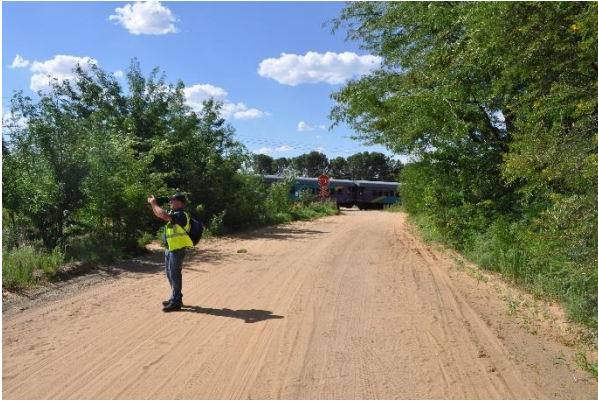
Figure 2: Stop sign on the approach to the level crossing

- 4.9.1 Around the vicinity of the level crossing, there was vegetation on both the left and right side of the road. The vegetation on the left side where the train was coming from covers around 100 meters towards the level crossing. Figure 2 also depicts the said vegetation.

- 4.9.2 Notwithstanding the fact that there was vegetation at the time of incident, the view at the compulsory “STOP” sign (which is within 5m from the railway crossing) was not obstructed. Therefore the truck driver’s visibility could not have been obstructed if he had stopped at the compulsory stop sign. Figure 2 also depicts the truck visibility from the stop sign.

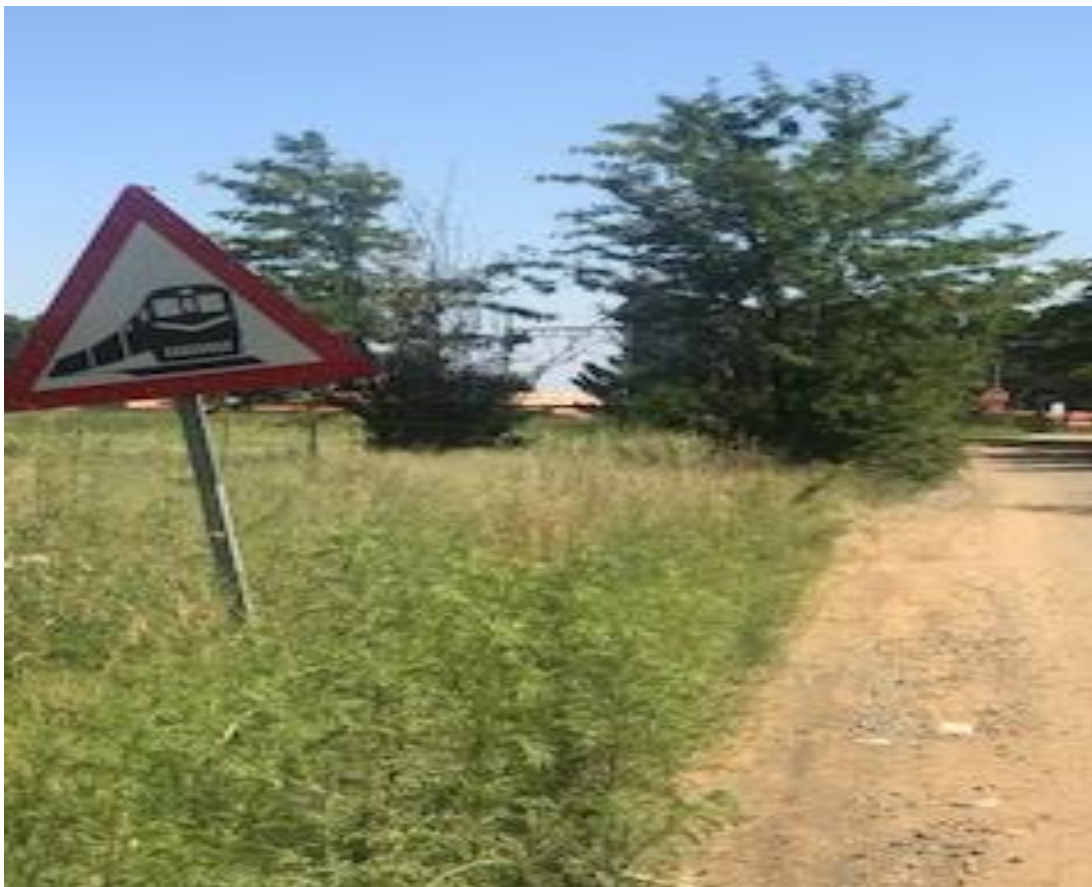
Figure 3: Advance warning sign and stop sign on the approach to the level crossing.

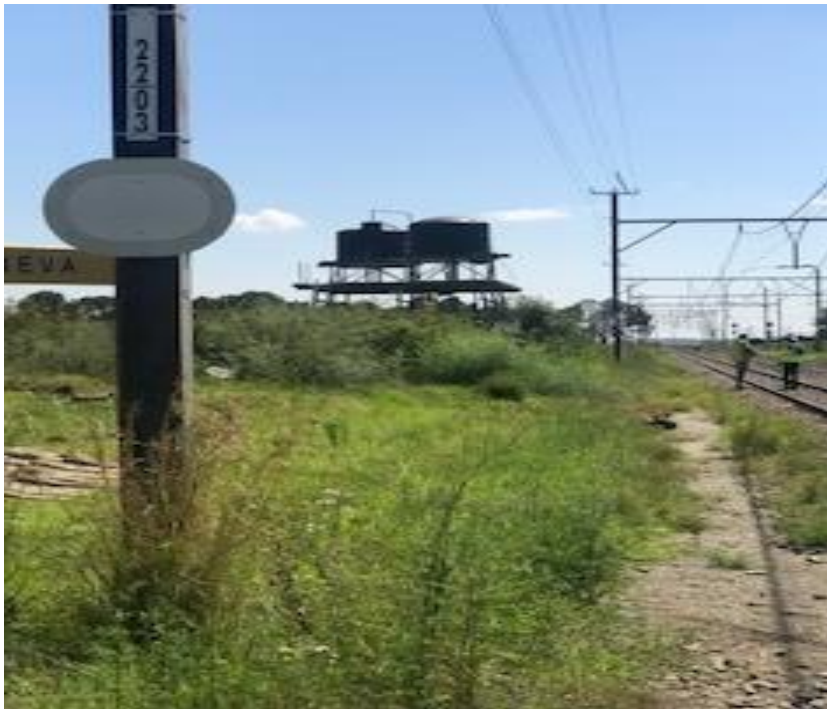
- 4.10 There were also two whistle boards at mast poles 22/03 and 21/16, which are located approximately 400 meters and 117 meters, respectively, before the level crossing. The purpose of these whistle boards is to ensure that the train driver blows the whistle before entering a railway crossing. **Figure 4** and **Figure 5** depicts the said whistle boards.

Figure 4: The first whistle board located 400 meters away from the level crossing

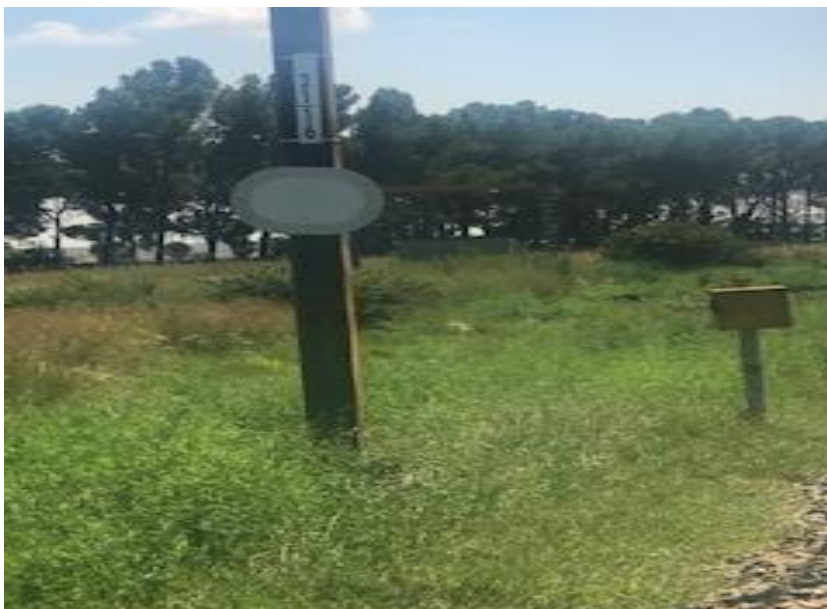
Figure 5: The second whistle board located 117 meters away from the level crossing

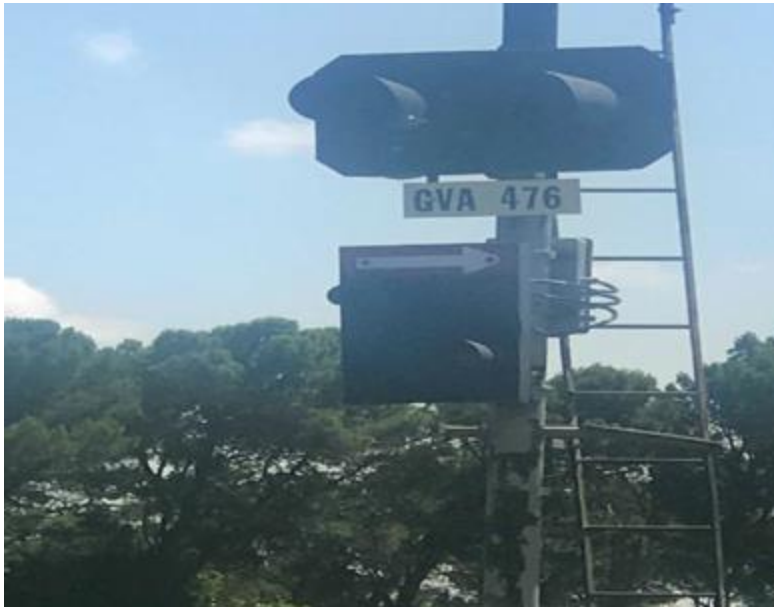
- 4.11 The signal, GVA 476 located between mast poles 21/16 and 21/15 gave the train a right of way. **Figure 6** depicts the said signal.

Figure 6: This is signal GVA 476 which was green and allowed the train to pass through the level crossing

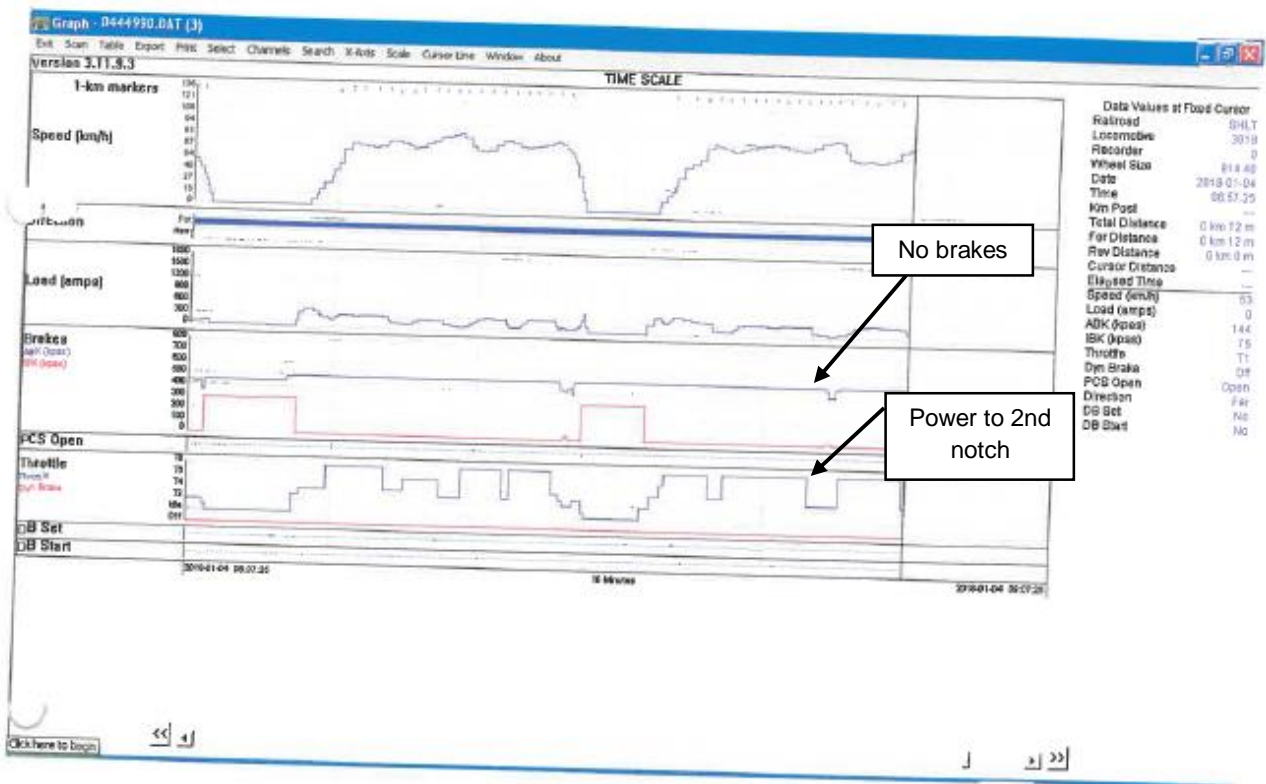
was a probable collision. The locomotive's black box report confirms that the train driver did not apply his brakes at any point since observing the oncoming truck. In addition, the locomotive's black box report demonstrates that the train was moving at 78 km/h at the time of impact which was within the permitted 90 km/h speed limit along the section. Figure 7 illustrates that the brakes were not applied and the train was moving at 78 km/h on impact.

Figure 7 : This is CPU evidence from the locomotive illustrating the speed and braking analysis during impact

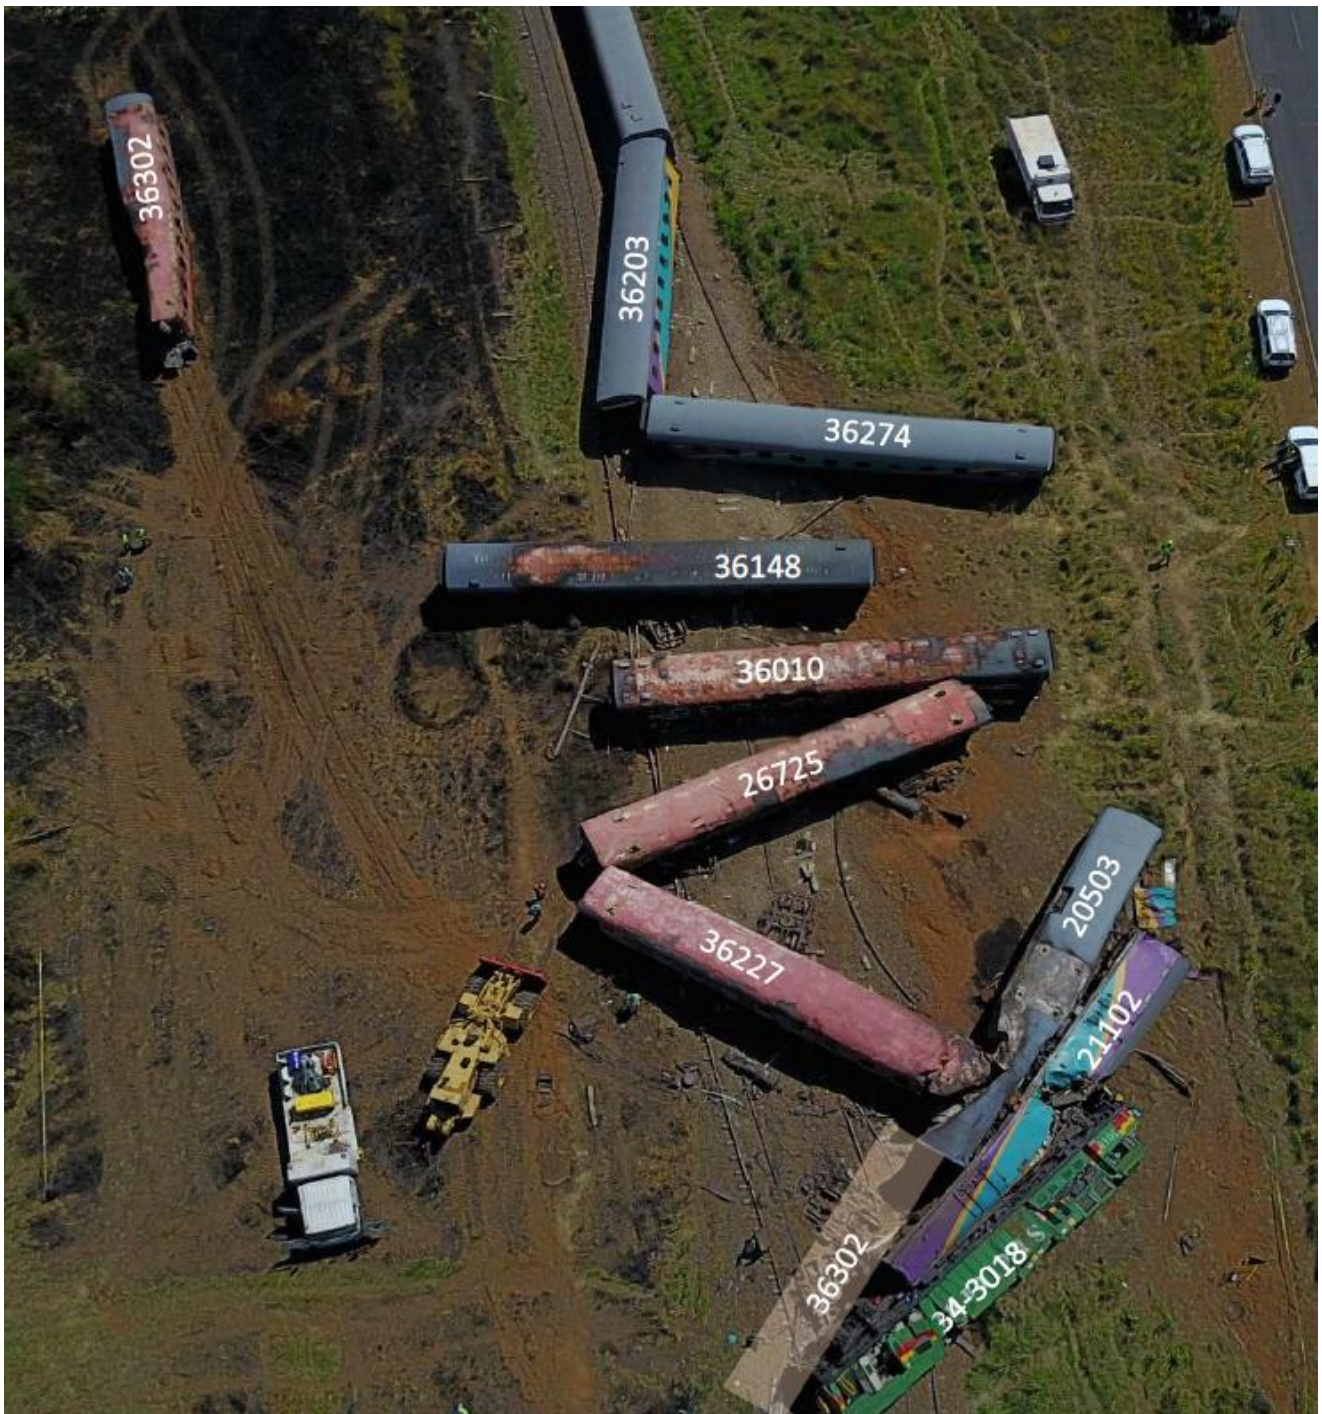
4.17 The derailment was as a result of the train's instability resulting from the collision between the train and the truck. A few minutes after impact, a fire arose which caused damage to rolling stock, shown in Figure 8, and the following coaches were burnt:-

Figure 8: Aerial view of fire damage.

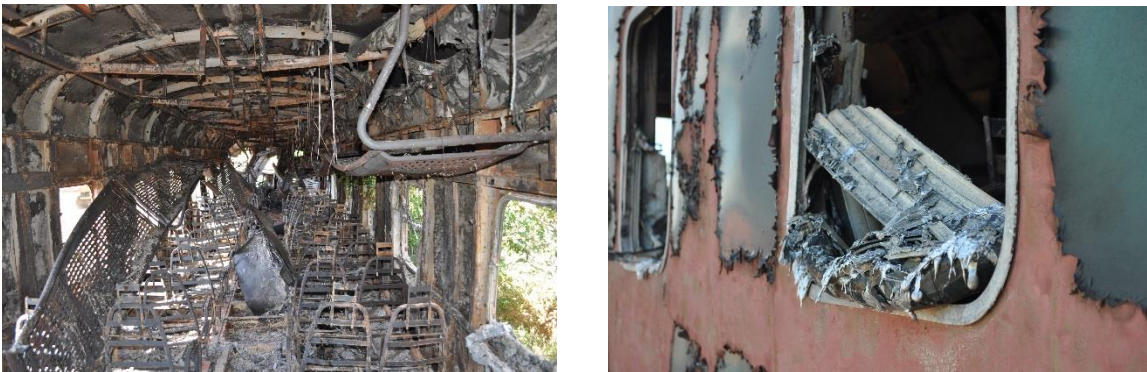
4.23 Evidence collected during the inquiry indicate that the fire started after the train derailed. Figure 9 show **the interior of** one of the coaches and the damage that was caused by the heat to the window frames.

Figure 9: Fire damage caused to the interior of the coach and window frames

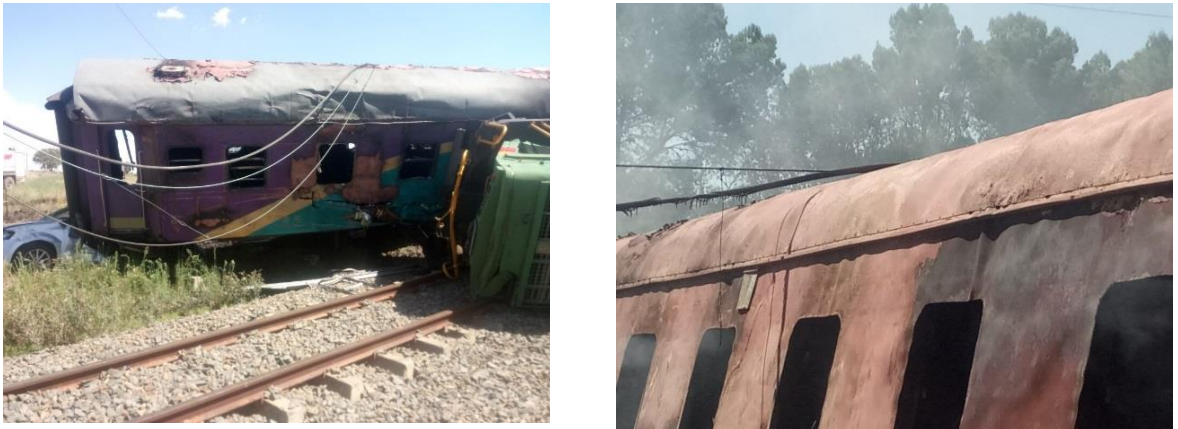
4.24 The fire was caused by arcing of the 3kV DC overhead track equipment that did not switch. The heat generated by the arcing onto the exterior of the coaches caused the interior to catch alight. Figure 10 shows the cable in contact with one of the coaches and the damage that was caused by the heat due to the arcing. This damage is a clear indication that the heat was generated from the cable as it arced onto the body of the coach and was not caused from an external source.

Figure 10: Overhead cables in contact with a coach

- 1.3.34 The RSR must investigate the reason for the failure of the OHTE to be switched automatically after the accident. Evidence that was provided show that a lack of maintenance might be a contributing factor.

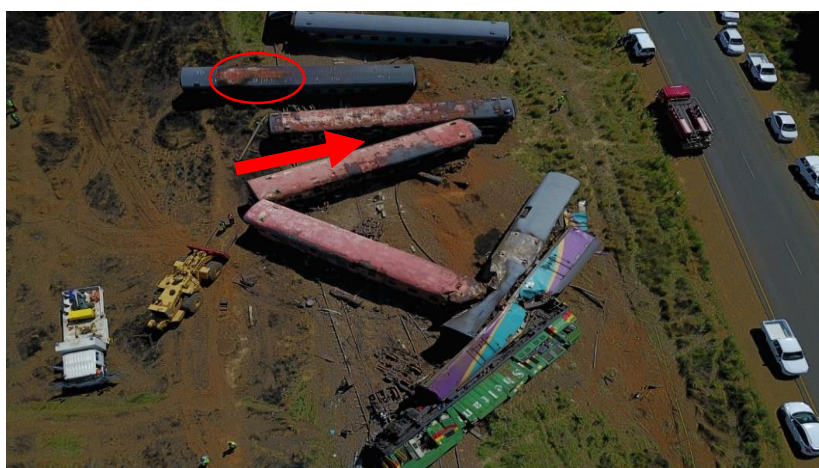
4.25 The cause of the fire is further endorsed through evidence that was presented during the interview of the assistant train driver, and the train manager, who indicated that the fire started a few minutes after the accident. Figure 11 show that the fire did not spread from one coach to the other due to radiation. Each coach was set alight separately by an external source most likely to be the overhead track equipment. The circle in Figure 11 clearly shows how a small area on the coach was burnt.

Figure 11: Coaches caught by fire indicating that the coaches were set alight separately.

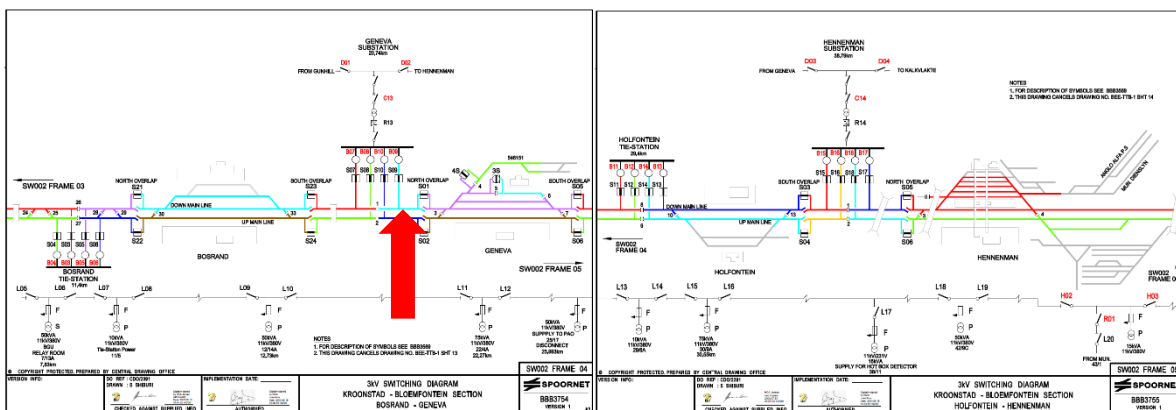
4.26 Interrogation of the switching data in the adjacent substations also showed that no breaker tripping was experienced in Holfontein tie-station or Henneman substation. This occurred as indicated in Figure 12.

Figure 12: Electrical switching diagrams

4.27 It could reasonably be expected that breaker B09 and B10 in Geneva substation and B11 and B12 in Holfontein tie-station should have tripped due to the fault caused by the accident. Henneman substation should also have been prevented from feeding into the fault through the tripping of B15 and B16. An analysis of the trip data, received from Transnet show that no tripping occurred at Holfontein tie-station and Henneman substation between 08:56:26 and 10:03:39. Switch S05 and S06 was manually opened by an electrician at 10:03:39.

4.28 There are two possible reasons for the failure of the breaker to trip during the fault. It could also have been a combination of both. These are:

4.28.1 The high resistance of the fault caused the breaker to be unable to detect the fault; or

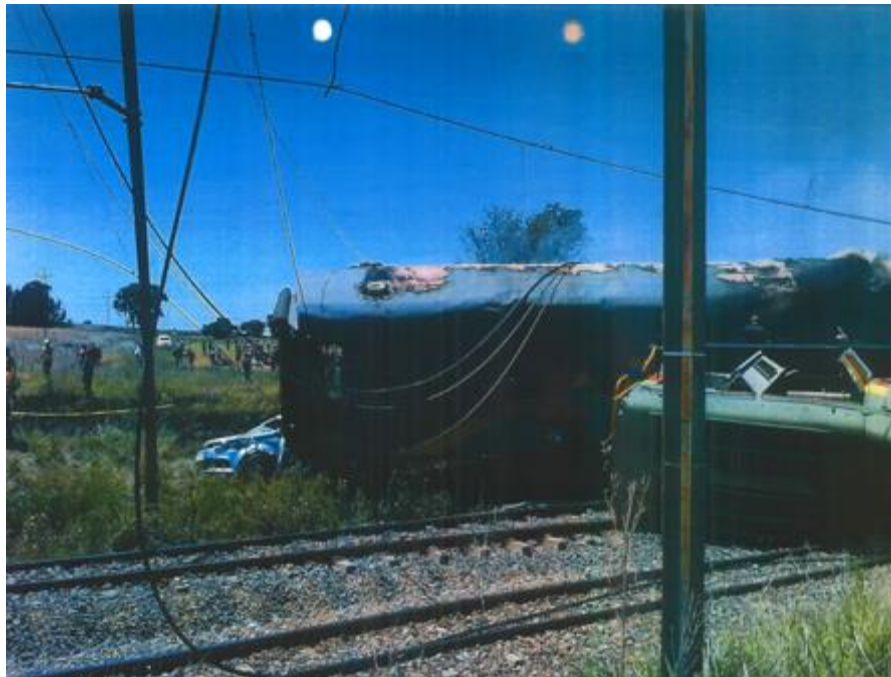
Figure 15: This is overhead hanging wires which made contact with the coaches

6.7.11.4 The overhead hanging wires which still generated power caused fire at contact with the coaches.

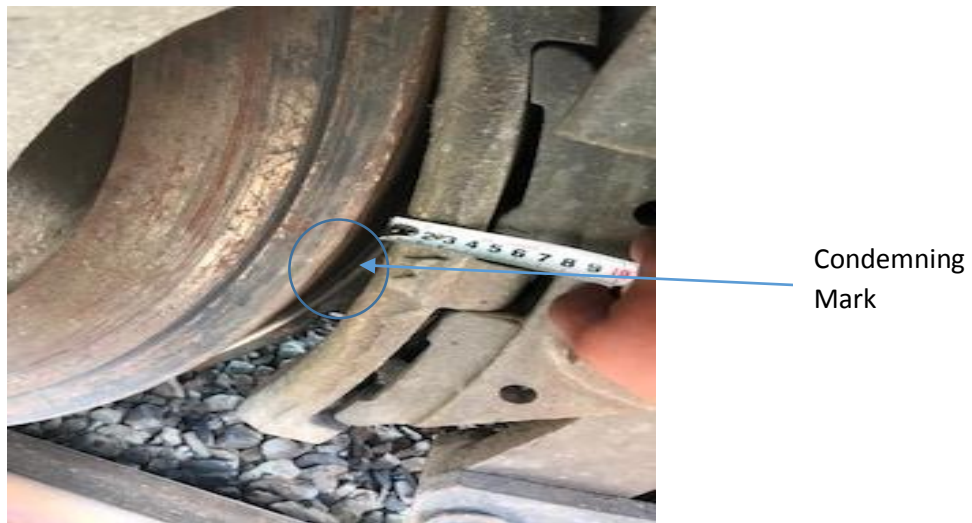
6.7.18 Figure 17 below is a picture of the brake blocks which illustrated that they were still within the wear limits as they had not reached the condemning mark

Figure 17: This is brake block still within wear limits

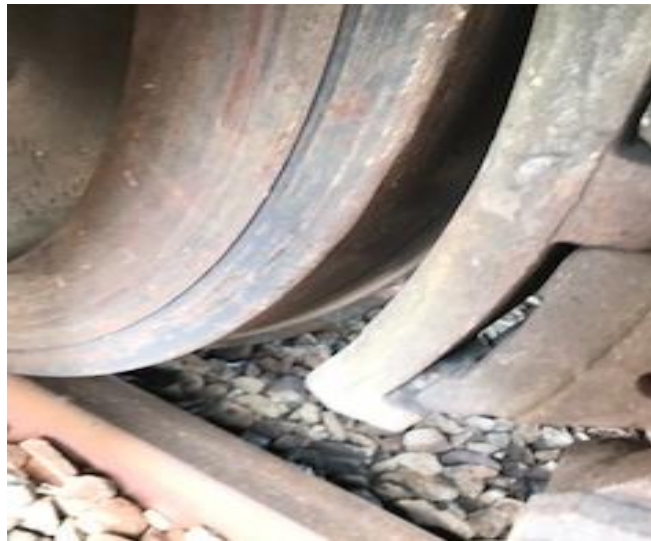
6.7.19 Locomotive wheels did not show any signs of abnormal wear patterns such as flange wear or hollow wear which could have caused the derailment of the train (see Figure 18 below)

Figure 18: Locomotive wheels with no signs of skid marks or soft spot

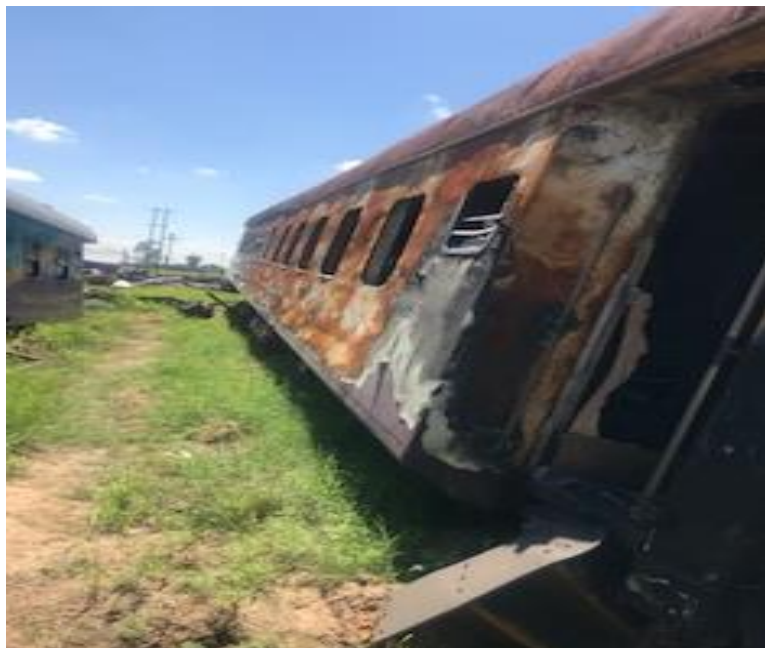
Figure 19: Burnt coach 26725 (exterior)

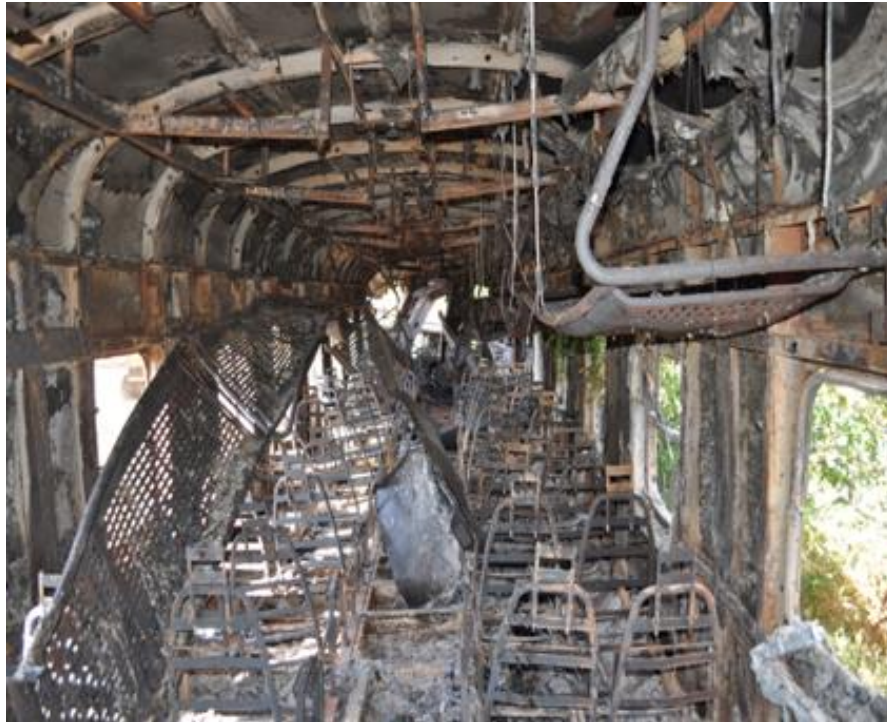
Figure 20: Burnt coach 26725 (Interior)

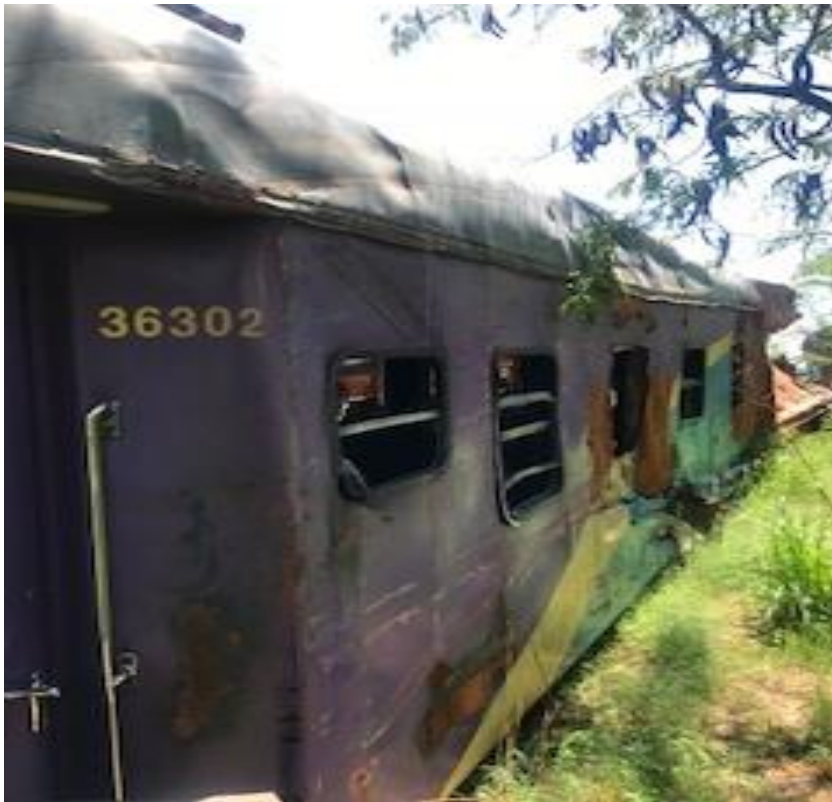
Figure 21: Burnt coach 36302 (exterior)
